36 INCH CAUSTIC DRUM, ALKYLATION PLANT

*Technowrap repair to eroding 36 inch Caustic Drum, Alkylation Plant.
Durban, South Africa.*

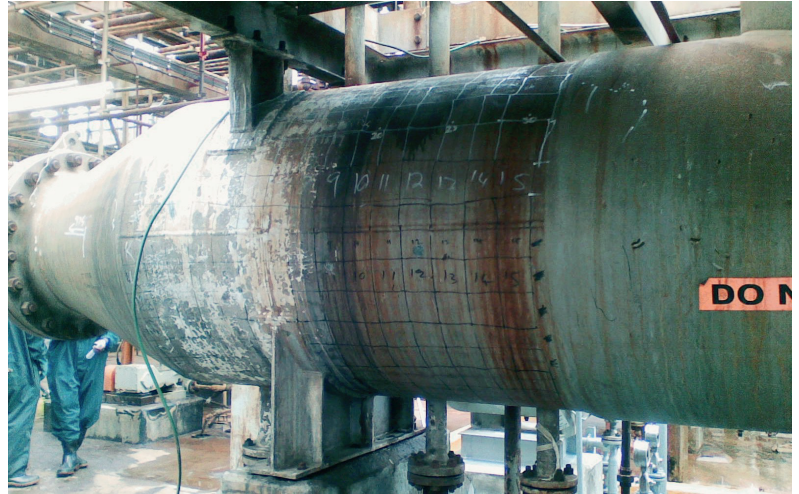
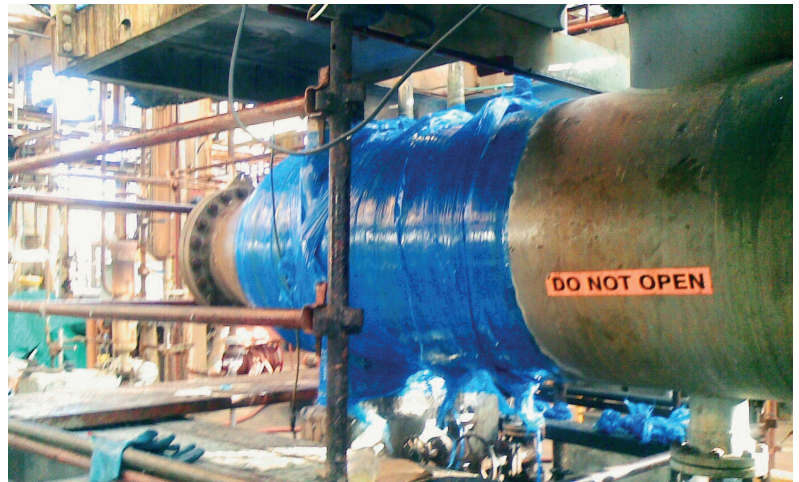
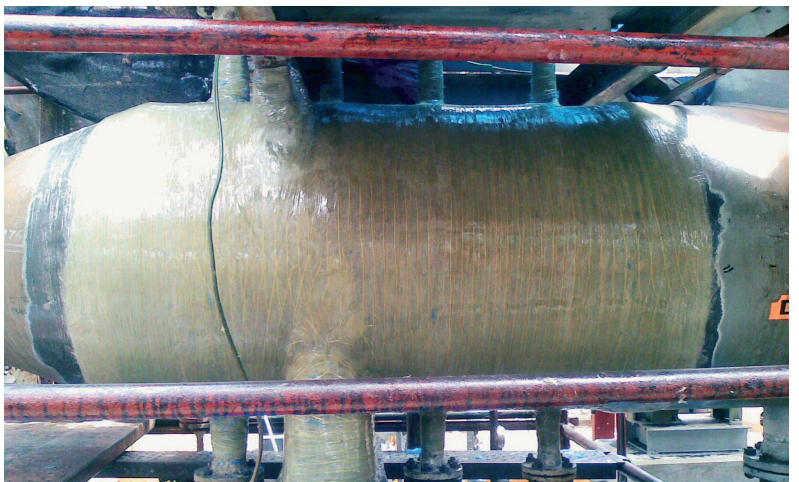
Refinery in Durban South Africa, 36 inch Caustic and Mereox drum experienced excessive internal erosion. Requirement was to reintroduce integrity to the Drum enabling operations to continue safely until next shutdown. Pressure at 7 bar and temperature at around 50 °C.

The main problem was that the unit had many complicated geometries, also the base had to be built up with cement to create a workable profile.

Calculations were done according to the information provided. The preparation was arranged and by the client to the required SA 2.5. The repair was successfully carried out over a 3 day period.
